**DRAFT REPORT  
ROUND 10 DAM ASSESSMENT  
ALLIANT ENERGY – NELSON DEWEY GENERATING STATION  
SLAG POND, WPDES POND  
CASSVILLE, WISCONSIN  
NOVEMBER 15, 2011**

RE: DRAFT Assessment of Dam Safety of Coal Combustion Surface Impoundments at the  
Nelson Dewey Generating Station

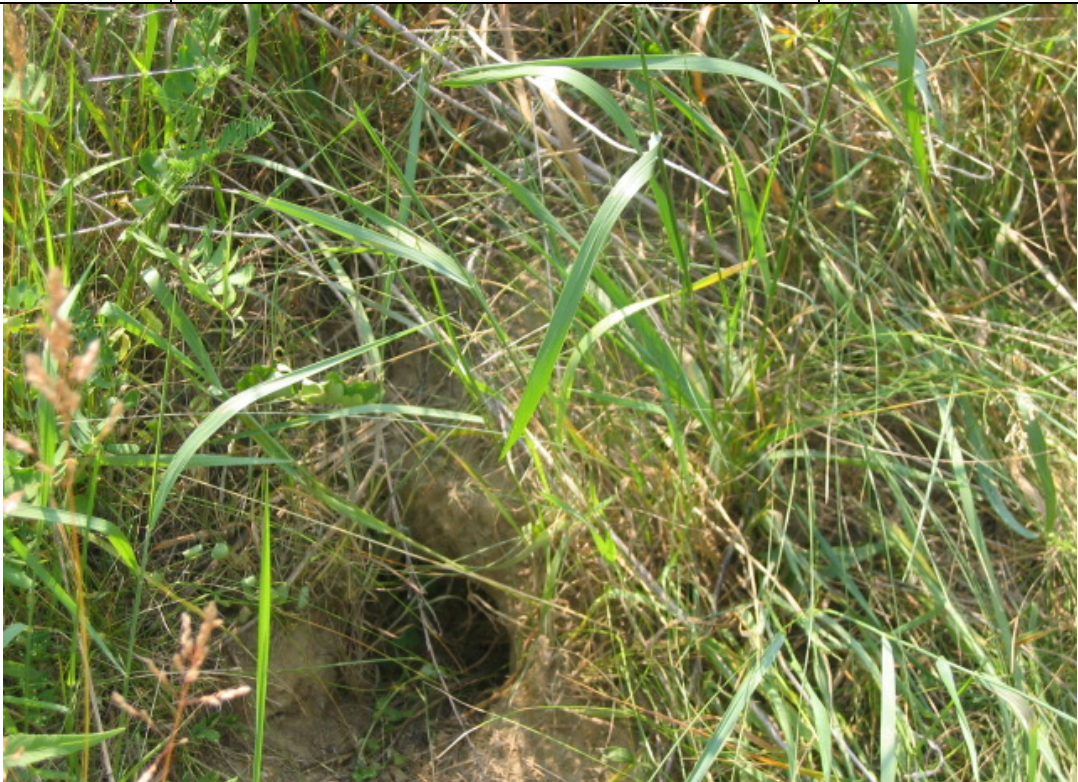
The crest of the Slag Pond had a gravel access road along the western, southern, and eastern embankments and was seeded along the remaining portions. The crest of the impoundment had occasional animal burrows present at the time of our inspection. The alignment of the crest of the impoundment appeared generally level with no large depressions or irregularities observed. Based on information provided by Alliant, the crest of the impoundment is at approximately elevation 625.0 feet MSL. No settlement was observed at the time of our inspection. There was approximately 8 feet of free board at the time of our inspection.

<b>Direction Photo Taken:</b> North			
<b>Description:</b> Animal burrow on the crest of the Slag Pond.

1. Repair sloughing on the downstream slope of the Slag Pond;
2. Protect the northwestern embankment of the Slag Pond from wave action erosion; and,
3. Control burrowing animals on and near embankment
4. Fill animal burrows.

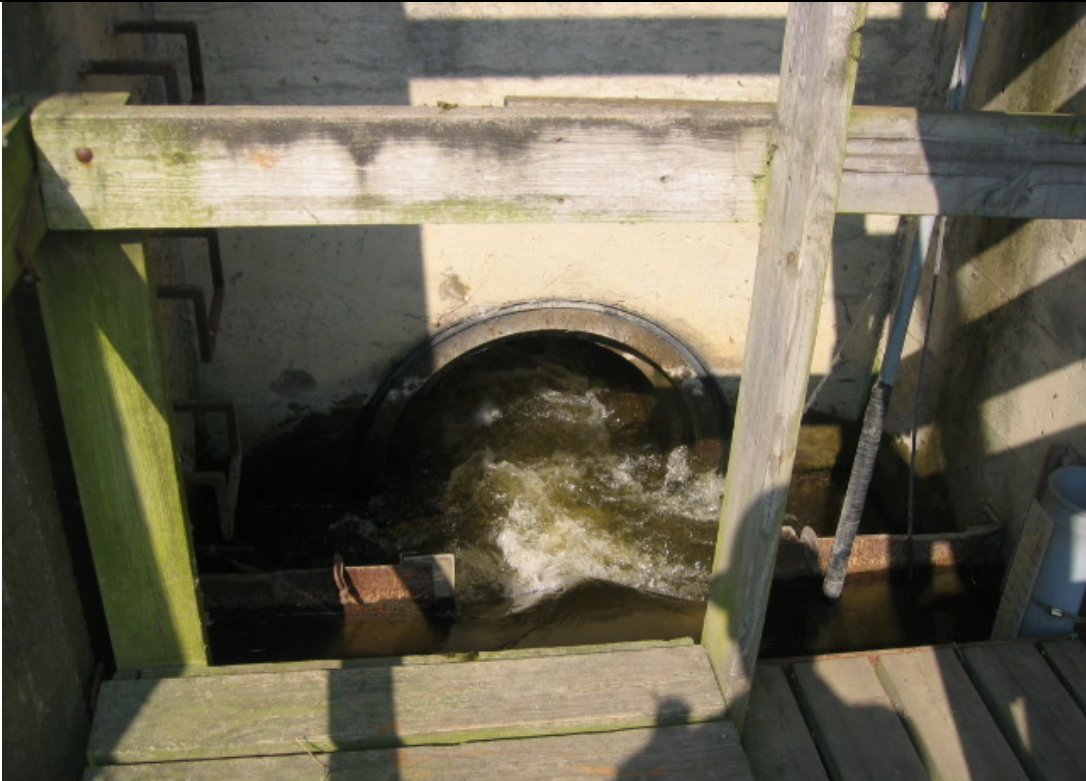
Water and CCW from the plant are discharged into the Slag Pond through a series of 12-inch diameter steel pipes which are located along the southern and eastern embankments of the impoundment. Water is discharged into the Slag Pond from the WPDES Pond through an 8-inch diameter HDPE pipe which is located near the northeast corner of the impoundment. The discharge pipes appeared to be in good condition. GZA observed the condition of the decant structure that transmits water from the Slag Pond to the Mississippi River. The decant structure appeared to be in good condition.

<b>Direction Photo Taken:</b> West			
<b>Description:</b> Decant structure and weir in the Slag Pond.

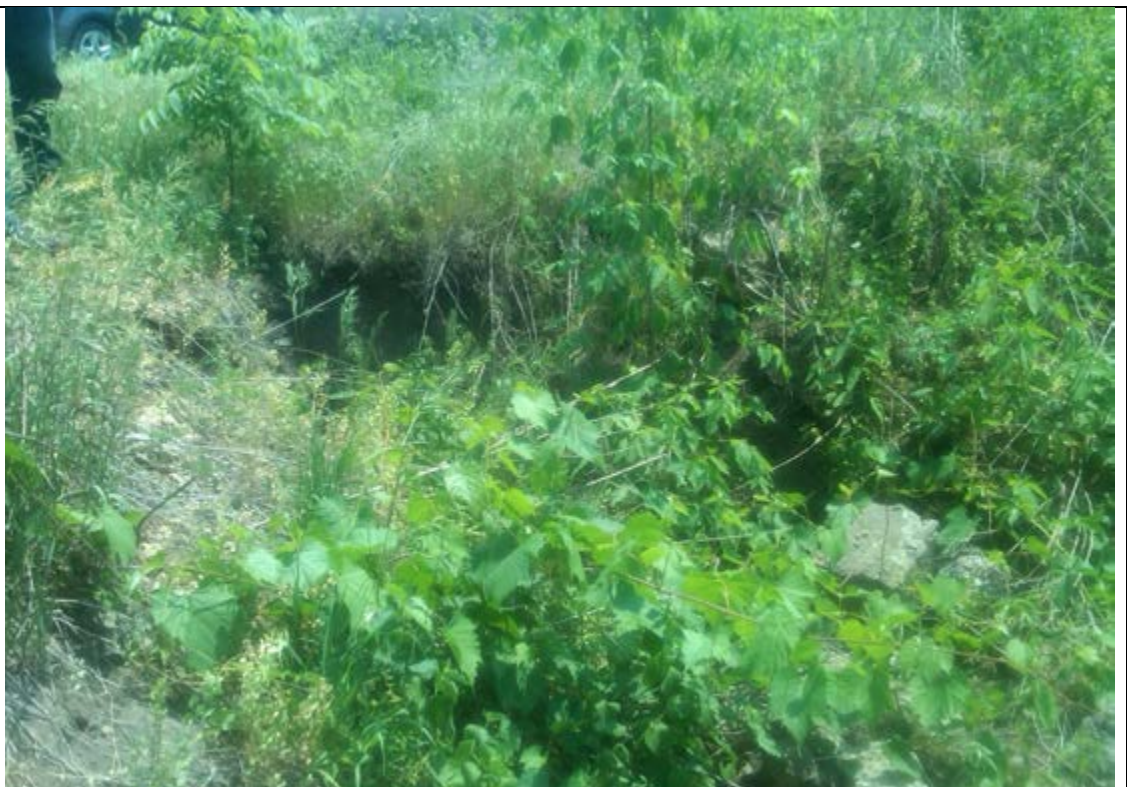
**Photo No.**  
**22**

**Description:**  
Erosional feature near the  
crest of the Slag Pond.
